12183

STRUCTURAL REPORT
St. John's Church
Westwood Heath
Coventry

December, 2020

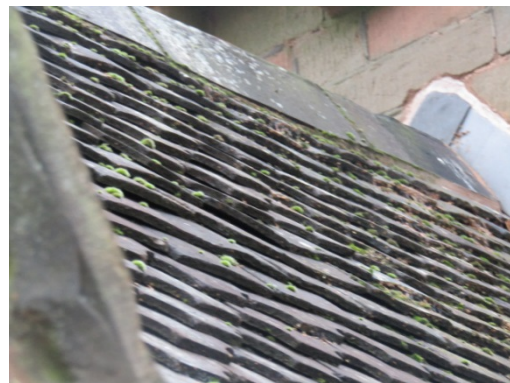
Photograph No. 2

Viewing is slightly restricted but from what could be seen there is some moss growth and an occasional disturbance to the tiles. What is noticeable is the gully at the base of the downpipe is full of leaves which should be cleared, and all of the above points are shown on photographs No. 2 and 3.

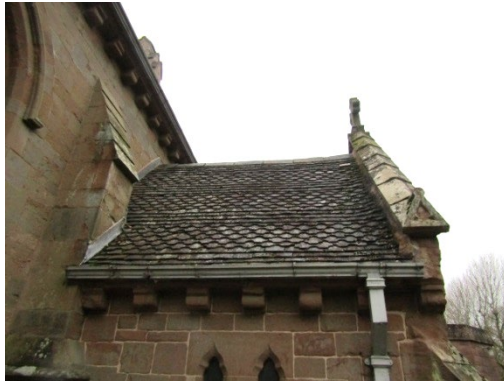
Photograph No. 4

The eastern side of the porch roof is shown on photograph No. 4 and it is evident where there has been a replacement tile but this in fact has slipped and the gutter is also full of vegetation. These points are shown on photographs Nos 5 and 6

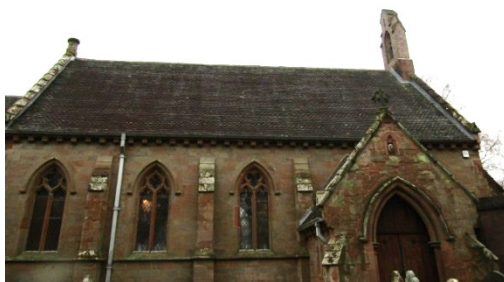
Photograph No. 7

Moving now to the northern slope of the nave roof as shown on Photograph No. 7, the ridge line is quite reasonable as are the main roof lines. To the tiles themselves, there are bands of feature tiles which are clubhead and reverse clubhead and at the western end, there is one missing as shown on photograph No. 8.

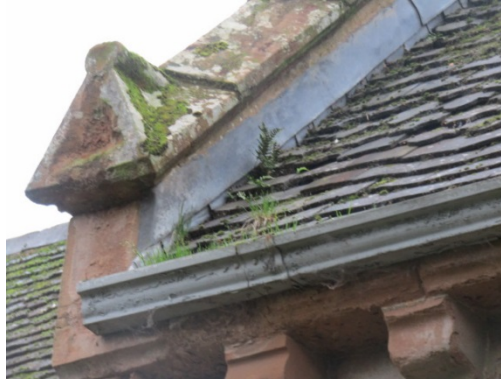
Photograph No. 9

At the eastern end, there are signs of small amounts of fern growth and again the gutters are full of vegetation, all as can be identified on photograph No. 9. The remainder looked in a reasonable condition.

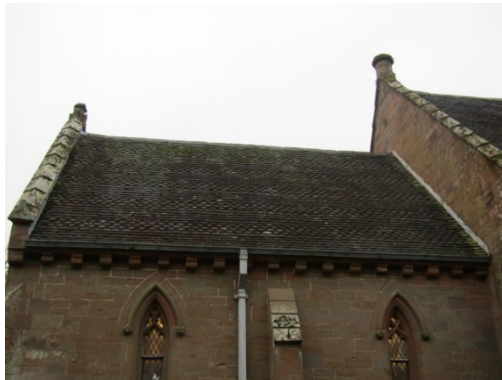
Photograph No. 10

Moving now to the chancel, as shown on photograph No. 10, the ridge line again looks in a reasonable condition. It is noted that there is a large amount of moss growth, as shown on photograph No. 11, and the gutters are full at the downpipes. It can also be seen where there is an occasional damaged tile or where one of the clubhead tiles has been replaced with a plain tile, these points being shown on photographs No. 12 and 13 respectively.

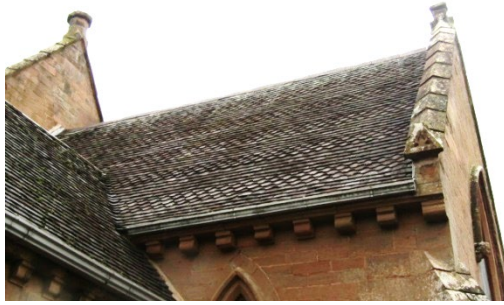
Photograph No. 14

Starting at the chancel roof, as shown on photograph No. 14, the ridge line is reasonable as noted on the northern side. There is an occasional chipped and damaged tile, an example is shown on photograph No. 15 but the lines are reasonable.

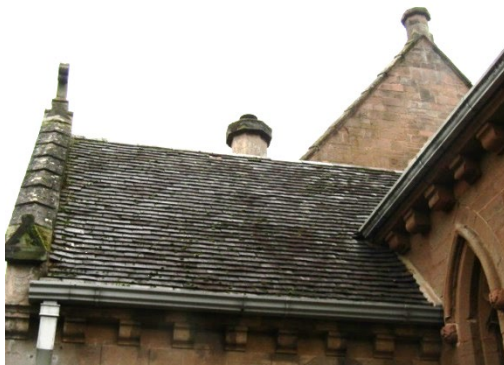
Photograph No. 16

Joining into this roof is the vestry, as can be seen on photograph No. 16, and again the ridge is quite reasonable as are the general lines but below the ridge, there is one missing tile, and this is identifiable on photograph No. 17.

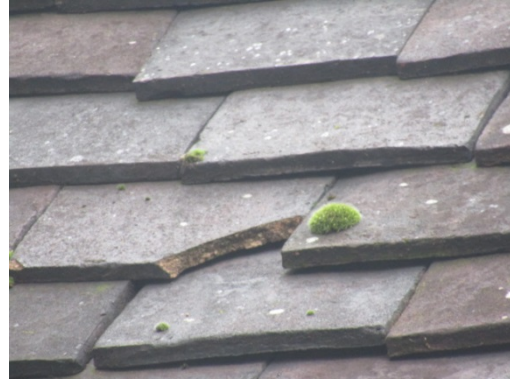
Photograph No. 20

On the western side of the vestry roof, as can be seen on photograph No. 18, there is again a large amount of moss build up, especially towards the southern side and also an occasional chipped tile, these points being shown on photographs No. 19 and 20.

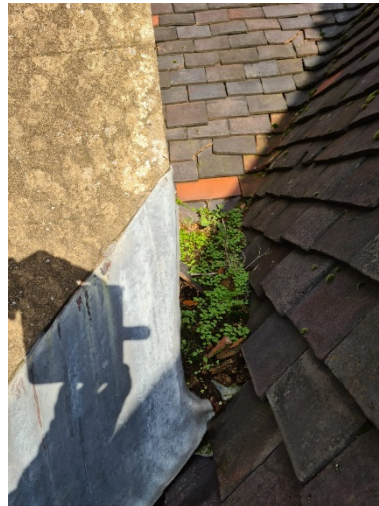
Photograph No. 21

It is also evident that in the valley with the main roof, there is quite a large amount of vegetative growth which needs to be removed. The main chancel roof itself is in a reasonable condition and has had replacement tiles. There is still an occasional one which is chipped, and the above points are all shown on photograph No. 21.

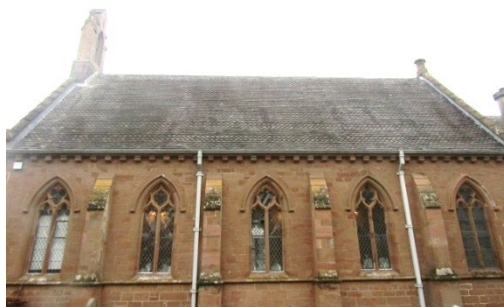
Photograph No. 22

On the southern nave roof, this is shown on photograph No. 22, and the general lines are again quite reasonable. There is noted to be an occasional missing tile underneath the ridge, as shown on photograph No. 23, and also an occasional slipped tile.

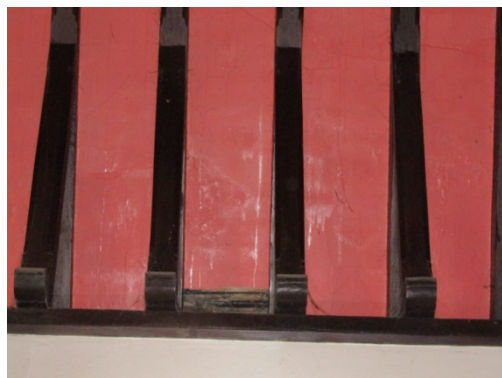
Photograph No. 26

Starting on the northern side, there is evidence that there is potentially condensation damage on the underside as there is a slight sheen to the plaster which is between the rafters as can be identified on photograph No. 26.

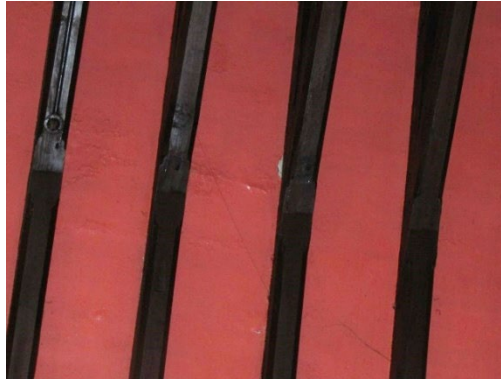
Photograph No. 27

There are localised areas of cracking to the plaster and this can be made out on photograph No. 27.

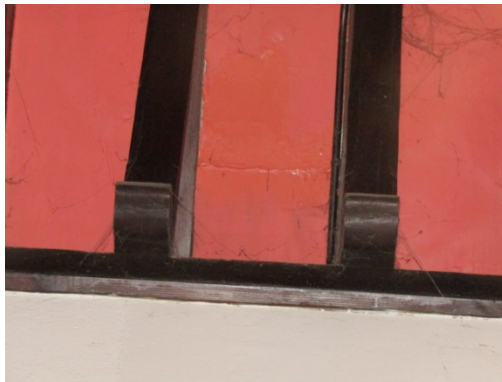
Photograph No. 28

On the southern side of the chancel, there are again some minor localised cracks through the plaster and again staining, which is potentially from condensation, the above points being shown on photographs No. 28 and 29.

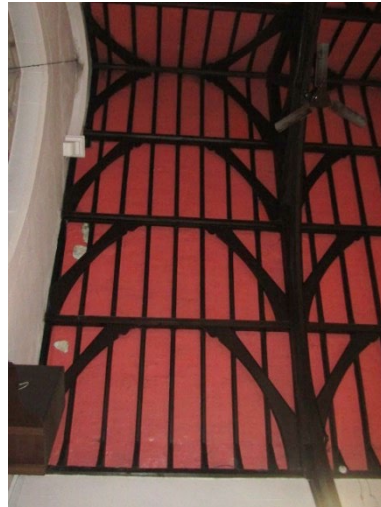
Photograph No. 31

In the north-western bay, there are 3 sections of deterioration which are shown in general on photograph No. 31 and then in more detail on photograph No. 32.

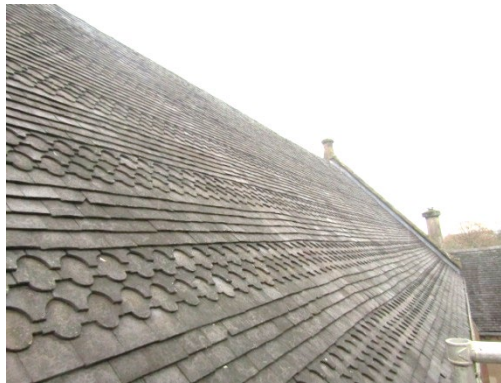
Photograph No. 41

Looking along the line of the roof, there were slight undulations in the tiles which potentially is an indication of the nail fixings to the battens failing so that there is a slight slump in the line which can all be appreciated on photograph No. 41.

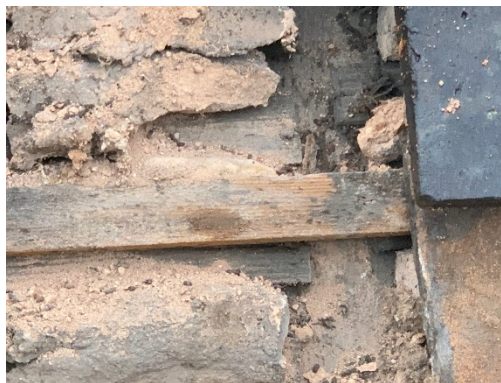
Photograph No. 45

There is again a reasonable key to the plaster through the laths but there was an indication that the nail fixings are corroding an example being shown on photograph No. 45.

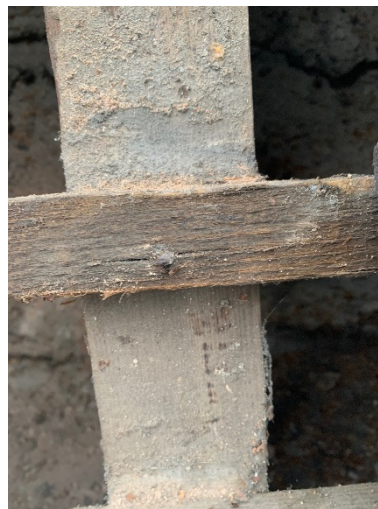
Photograph No. 48

On the battens, the nails are corroding which is causing a very slight split which can be seen on photograph No. 48.

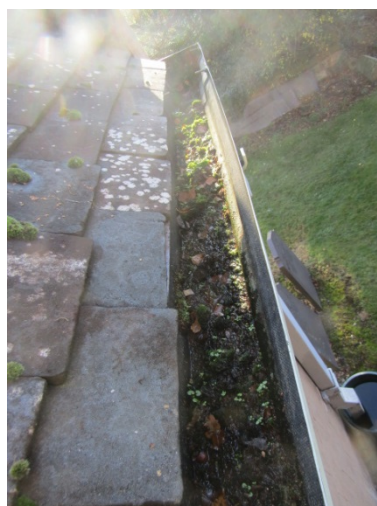
Photograph No. 50

It is evident, as can be seen on the photograph above, that there is boarding on top of the rafters and then the battens are fixed to the boarding. Generally, this all appears to be working quite adequately and there were no signs of any major distress. The one item to note is that the guttering was full of vegetation as noted on photograph No. 50.

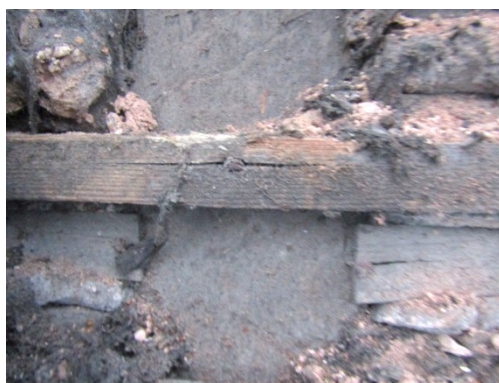
Photograph No. 53

The plaster key is quite reasonable coming through the laths but there are signs that the nails fixing the battens are corroding which is splitting the timber as shown on photograph No. 53.

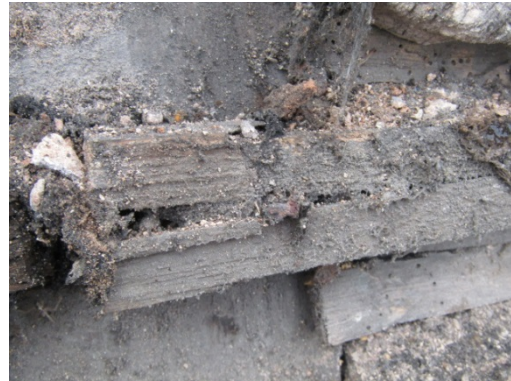
Photograph No. 57

What is evident is that the battens are starting to split at the nail positions and a more detailed view is shown on photograph No. 56 and then splitting of the battens with the nail on photograph No. 57.

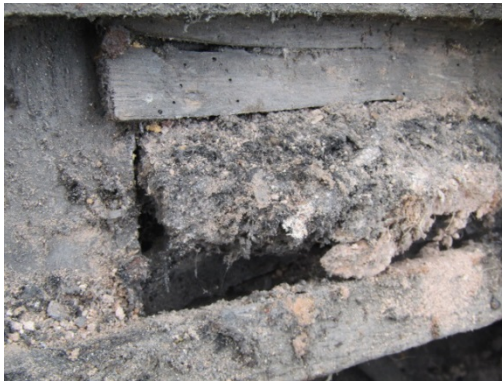
Photograph No. 58

It could also be seen that there was a small amount of beetle infestation to the battens and towards the lower section, there is a small area of rot where one could be removed, and the above points are shown on photograph No. 58 and 59.

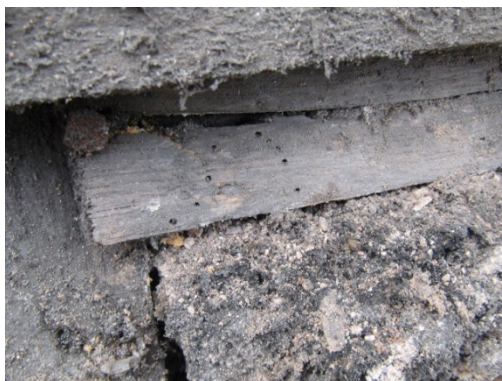
Photograph No. 60

The plaster itself would appear to have a reasonable key, however, on the lath there is a small amount of beetle infestation as shown on photograph No. 60 and again on photograph No. 61 which also shows where it has been split by the corroding nailing fixing.

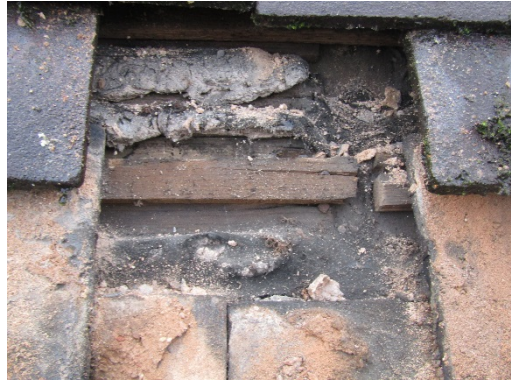
Photograph No. 63

Just above here to the main section, a further area was inspected which did show a reasonable plaster key but a similar situation and again it is clearly evident that the sequence of construction was that the rafters were constructed, then the ceiling laths put in place and then the roofing battens on top. The splitting at the end of the battens and the laths is clearly evident and this is all shown on photograph No. 62, which is a general view, and then in more detail on photograph No. 63.

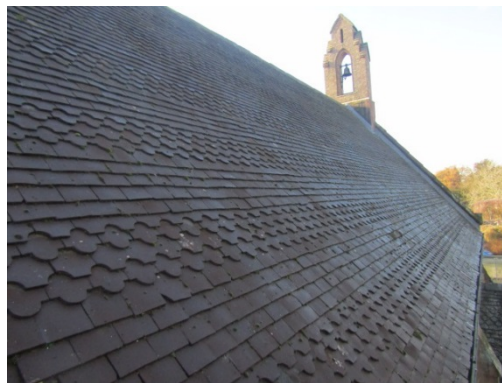
Photograph No. 66

Looking along the line of the roof, looking to the west, the line of the tiles is generally quite reasonable, however, there is an occasional slight sag in the line of the tiles indicating that the battens have dropped slightly and this can be seen on photograph No. 66.

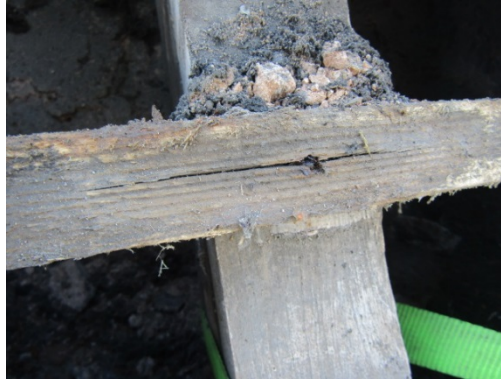
Photograph No. 67

Starting at the lower eaves section, the rafters are 100mm x 60mm at 390mm centres with the tiling batten being 25mm wide x 15mm deep at 115mm centres. The main item to note is that there is again slight splitting of the batten through the corroded nail fixing as can be appreciated on photograph No. 67.

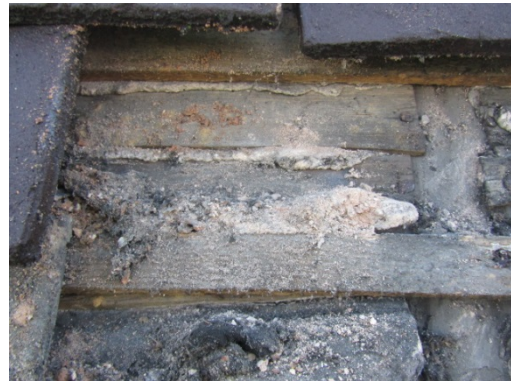
Photograph No. 69

On the upper section, as shown on photograph No. 68, the relationship of the laths for the ceiling and the battens is similar and again there is a reasonable plaster key coming through the laths with just an occasional section having broken off and this can be seen on photograph No. 69.

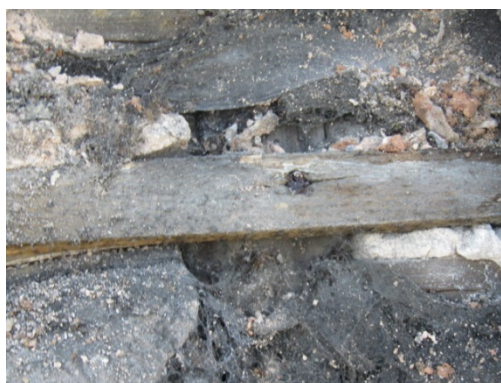
Photograph No. 70

The main item to note is that the nails are corroded on the battens, a further example being shown on photograph No. 70.

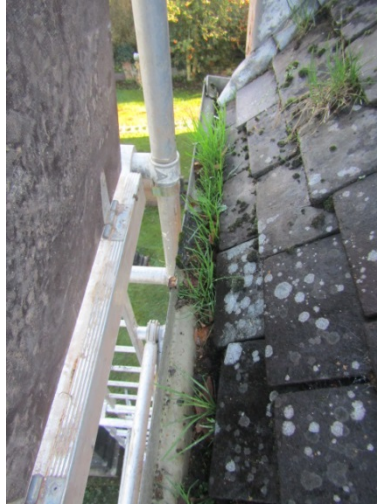
Photograph No. 71

Whilst at the eaves, it was noticeable that the guttering was full of vegetation as noted on the survey from ground level and a further record is shown on photograph No. 71.

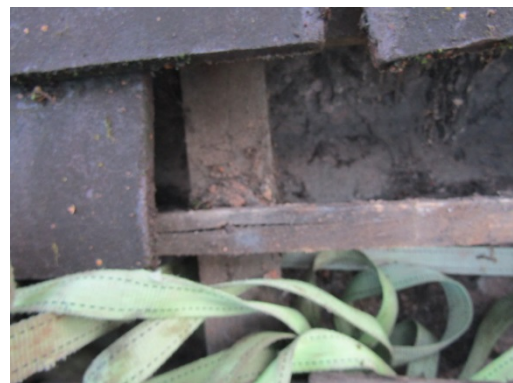
Photograph No. 73

This is taken to the east of the porch on the main nave roof and where the lower eaves was exposed, as shown on photograph No. 72. There is again evidence where the battens are splitting. The remainder is all as previously recorded on the other areas and this section is shown in more detail on photograph No. 73.

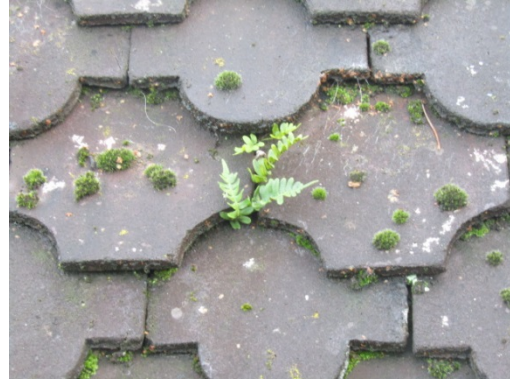
Photograph No. 75

The upper area of roof which was exposed can be seen on photograph No. 74 and it was noticeable that there was moss and a small fern growth on the roof as identified on photograph No. 75.

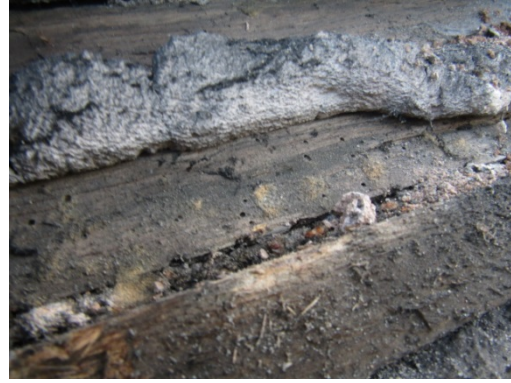
Photograph No. 80

The plaster key is quite reasonable but in this instance there was slight beetle infestation in the batten and the above points are shown on photographs No. 79 and 80.

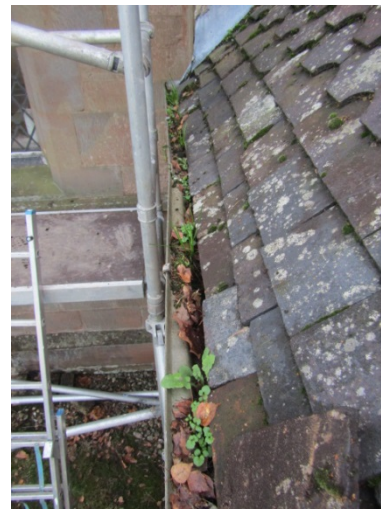
Photograph No. 84

Looking from this position, at the junction with the buttress, there is vegetation in the small back gutter and the main gutter itself is full of vegetative growth, these points being shown on photographs No. 83 and 84.

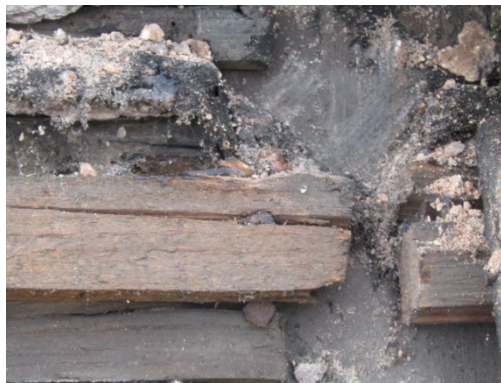
Photograph No. 84

The main issue with the roof is the battens and the fact that the nails have corroded over time. There are examples in nearly each area exposed where the corrosion of the nail has split the batten a typical example being shown in detail on photograph No. 85

When the nails corrode, then there is an expansion which thus splits the relatively thin timber batten or lath. At present, there was no indication of major failure, however looking along the lines of the tiles, that there were small areas where the line was starting to sag slightly which is an indication that the battens have dropped

In terms of timescale for major roofing works, the main issue will be the battens and therefore the recommendation will be that the roof will need re-covering within the next 5 years. In the interim period, carrying out regular maintenance would be recommended, and it has been noted that this is already being carried out noting that flashings have recently been replaced.
