12183

STRUCTURAL REPORT
St. John's Church
Westwood Heath
Coventry

December, 2020

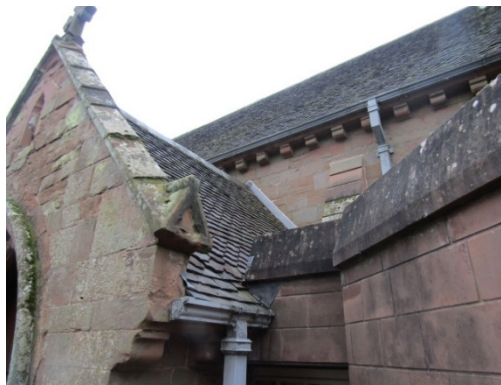
Photograph No. 1

Prior to the intrusive surveys, a visual inspection from ground level was carried out. Starting on the western slope of the porch, a general view is shown on photograph No. 1.

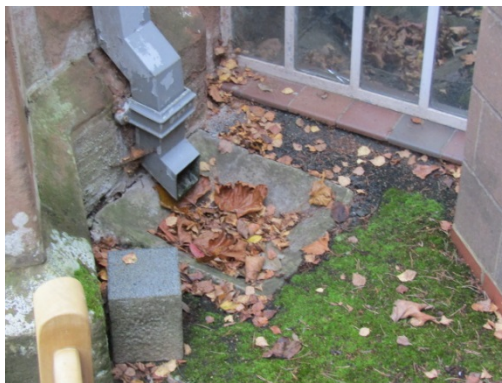
Photograph No. 2

Viewing is slightly restricted but from what could be seen there is some moss growth and an occasional disturbance to the tiles. What is noticeable is the gully at the base of the downpipe is full of leaves which should be cleared, and all of the above points are shown on photographs No. 2 and 3.

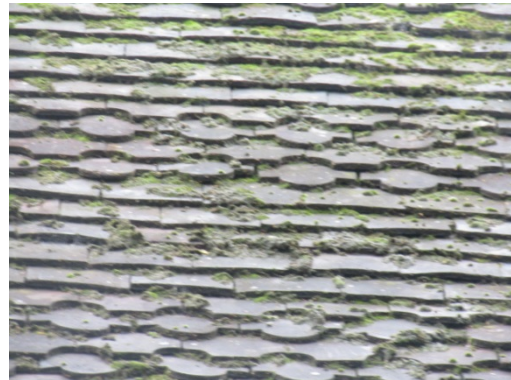
Photograph No. 11

Moving now to the chancel, as shown on photograph No. 10, the ridge line again looks in a reasonable condition. It is noted that there is a large amount of moss growth, as shown on photograph No. 11, and the gutters are full at the downpipes. It can also be seen where there is an occasional damaged tile or where one of the clubhead tiles has been replaced with a plain tile, these points being shown on photographs No. 12 and 13 respectively.

There is quite a large covering of moss over areas of the roof which again would be better removed as it is felt that this again holds moisture on the tiles which can lead to an accelerated deterioration of the tile itself. In the immediate short term, the most pressing matter is to make sure that the gutters are all fully cleared so that the water can adequately discharge, and this includes making sure that downpipes and gulleys also fully function.

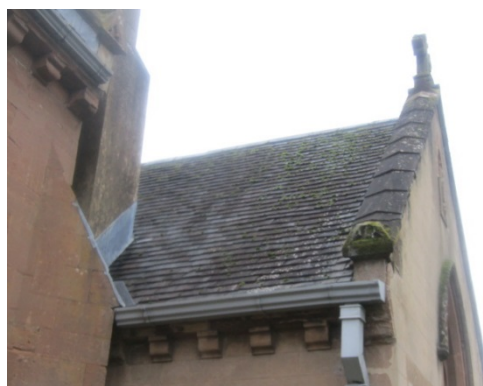
Photograph No. 18

On the western side of the vestry roof, as can be seen on photograph No. 18, there is again a large amount of moss build up, especially towards the southern side and also an occasional chipped tile, these points being shown on photographs No. 19 and 20.

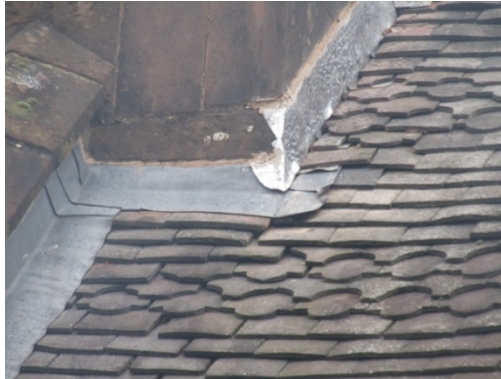
Photograph No. 24

At the western end, there has been recent work to the flashings which is clearly identifiable and generally this is all quite sound, and this is recorded on photograph No. 24.

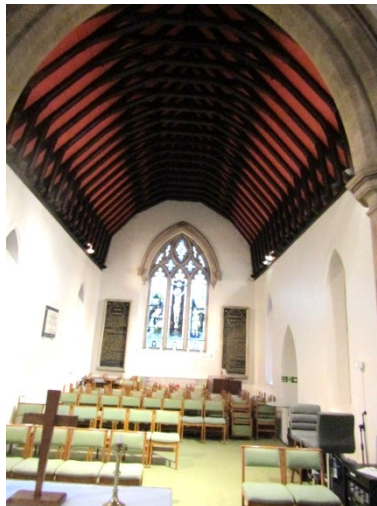
Photograph No. 25

Starting in the chancel, the roof consists of a series of collar tie rafters with a vertical post and triangulation at the wall head, a general view of which is shown on photograph No. 25.

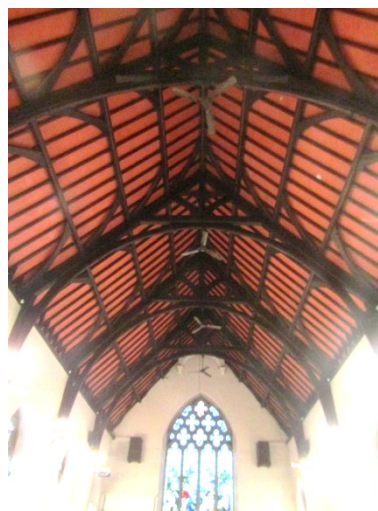
Photograph No. 30

Moving now into the nave, as can be seen on photograph No. 30, the roof has 5 bays which have 3 purlins to each pitch and also a ridge.

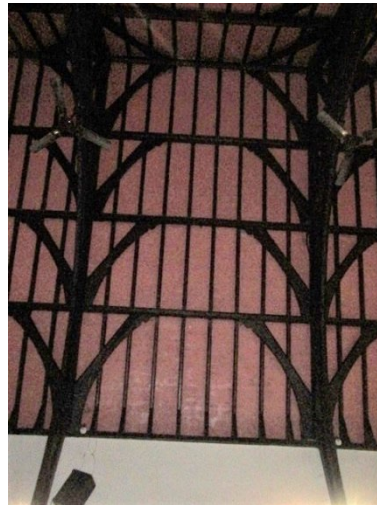
Photograph No. 33

Generally, the timbers are all working quite adequately, and it is noted that the bays are braced, and a typical bay can be seen on photograph No. 33.

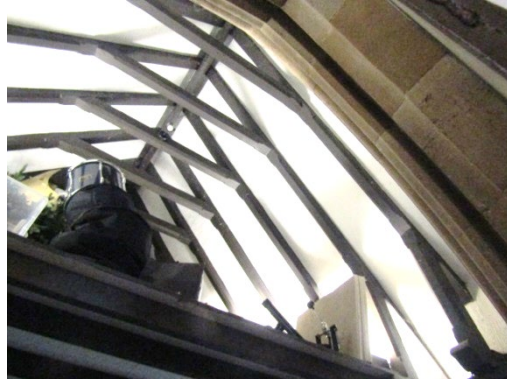
Photograph No. 34

In general, there are small areas of plaster damage which have been identified in the quinquennial report but the main item to note is that the roof timbers are in a reasonable condition with no indication of any failure. In the porch, there are collar tie rafters with a ridge, a general view being shown on photograph No. 34, and on the ceiling, there are items of storage, so viewing was slightly restricted. From what could be seen, there are irregularities in the plasterwork between the rafters but the timbers themselves were working quite adequately.

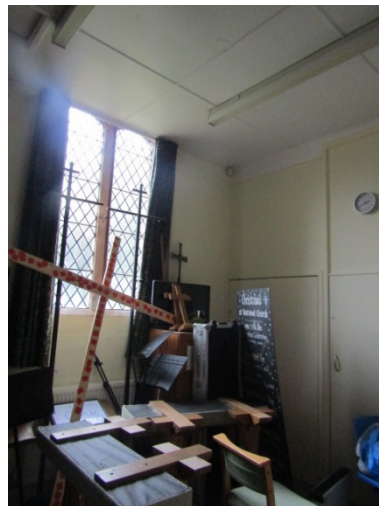
Photograph No. 35

The last area is the vestry where there is a suspended ceiling, a general view being shown on photograph No. 35.

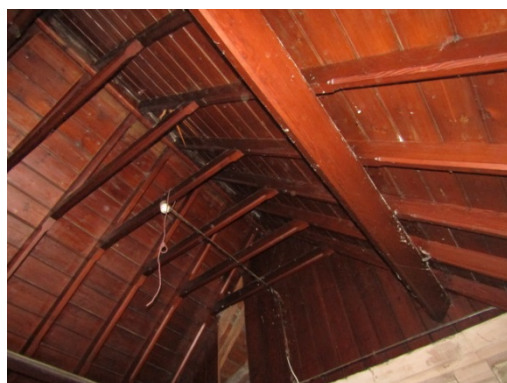
Photograph No. 36

Access could be gained to view above this level which showed that there are again collared rafters but there is a purlin and on top of the rafters, this is boarded, a general view being shown on photograph No. 36. The main item to note was the fact that there was no indication of any major structural failures and the roof timbers all appeared to be working quite adequately.

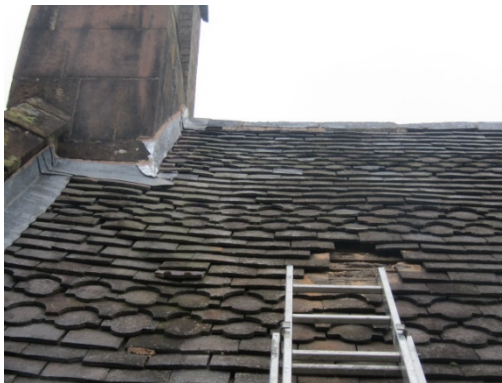
Photograph No. 37

This is at the western end of the southern pitch of the nave roof and a general view of the area inspected is shown on photograph No. 37 and in detail on photograph No. 38. This showed that the ceiling laths were fixed on top of the rafters and then the roofing battens on top, therefore there is very little space between the two.

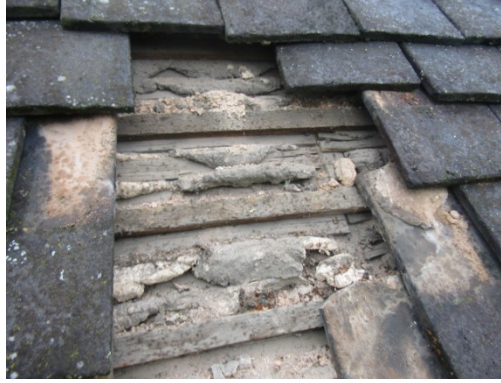
Photograph No. 39

It is evident that when the tiles were lifted, the top face of the ceiling could be seen with the plaster coming between the laths and there is a good key as shown on photograph No. 39.

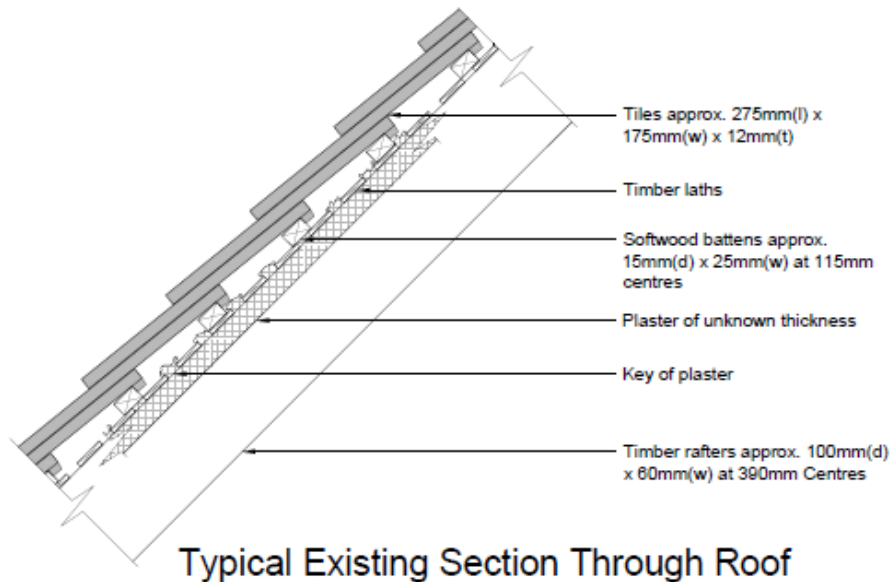
In the area inspected, the battens for the tiles were in a reasonable condition and the laths for the ceiling again were working quite adequately. There was an occasion where there was a slight split in the lath where it is nailed to the rafter but overall, it was working quite adequately. A typical section through the roof is shown below.

The method of construction was that the laths for the ceiling were fixed to the top of the rafters and then the roofing battens directly on top as can also be appreciated on the photograph above. This gives little gap between the underside of the tiles and the ceiling plaster. Internally, there were areas where there was a sheen to the plaster which is more than likely condensation. Condensation, in simple terms, occurs when warm moist air hits a cold surface and returns to a liquid state and with there being a lack of gap between the ceiling and the underside of the tiles, there is no insulation and very little airflow, hence condensation is likely to occur.

In planning any scheme of re-covering, it should be appreciated that due to the close relationship of the roof battens and the ceiling laths, with the former often being on top of the latter, that the ceiling will most likely be lost during the works. Removing the roofing battens and corroded fixings will cause significant vibration through the timber causing a disturbance to the plaster. In the reinstatement then this will provide an opportunity of including insulation, suitable roofing felt and air gaps.

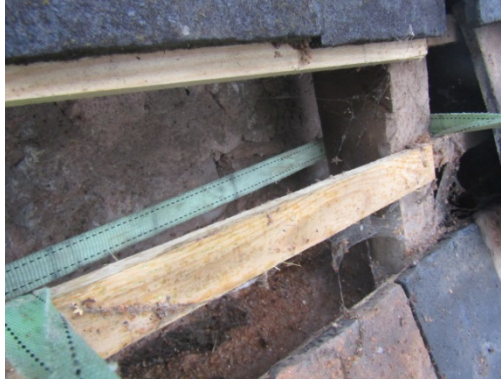
Photograph No. 40

At the eaves level, a few tiles were removed to secure the ladder, but it could be seen that the rafters, which are approximately 100mm deep x 55mm wide at just over 400mm centres, are set on a wall plate. There are also new softwood battens which have been introduced so there has been a repair at this point and these can be identified on photograph No. 40. In general, the timbers seemed in a reasonable condition showing no signs of any significant structural distress.

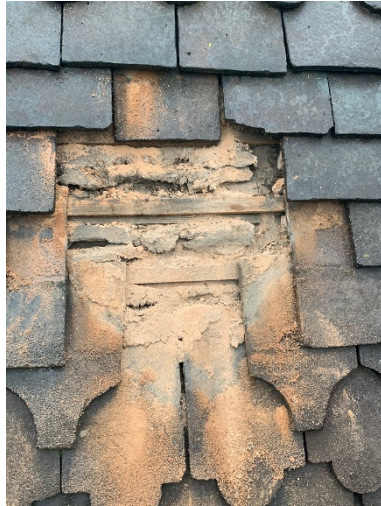
Photograph No. 42

This was taken at the eastern end of the nave roof above the eaves, a general view of which is shown on photograph No. 42. This showed an identical detail to area 1 and it can clearly be seen on photograph No. 43 where the roof battens and the laths for the ceiling overlap.

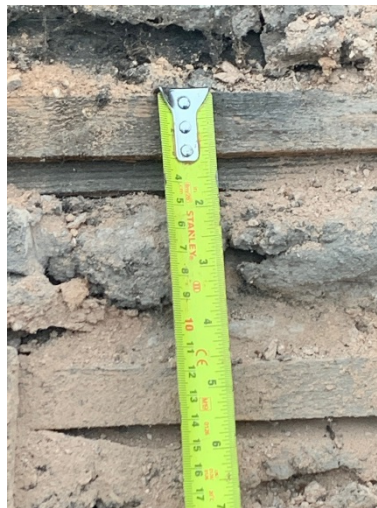
Photograph No. 44

The battens supporting the tiles are 27mm wide x 15mm deep at approximately 120mm centres as shown on photograph No. 44.

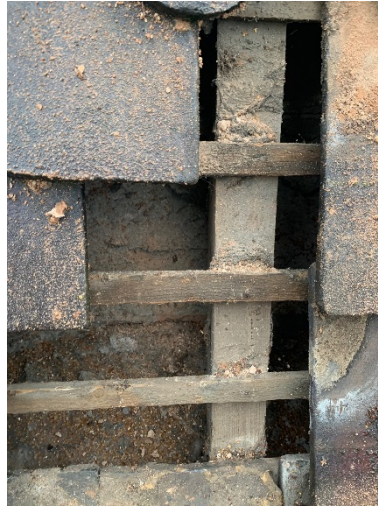
Photograph No. 46

At the eaves level on top of the wall head, there is no ceiling plaster, therefore the rafter could be viewed which was in a reasonable condition. It was evident that to the back of the inner wall plate, there was a localised area of beetle infestation and a general view of the area is shown on photograph No. 46 and the beetle attack on photograph No. 47. It should be noted that this would appear to be quite localised.

If rainwater, during heavy storms, starts to overspill, then this will sit on the wall head and cause rot to the wall plate and the ends of the rafters. The timbers generally showed no major signs of distress, however, there were small areas where beetle infestation (woodworm) was noted. These areas were not considered excessive and often this is induced where there is slight softening of the timbers through damp ingress. Generally, the laths and tile battens didn't show extensive damage with only small areas where the ceiling lath had small holes indicating beetle damage. Where this was identified, then the wall plate was still functioning, therefore it is not considered that immediate intervention is required but during the re-roofing works, then allowance for some minor areas of timber replacement would be prudent.

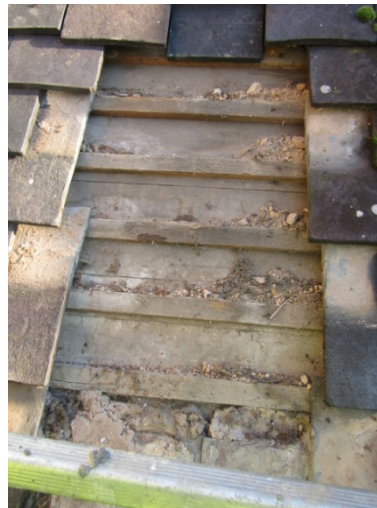
Photograph No. 49

This is on the western side of the vestry roof and a general view of this area is shown on photograph No. 49.

It is evident, as can be seen on the photograph above, that there is boarding on top of the rafters and then the battens are fixed to the boarding. Generally, this all appears to be working quite adequately and there were no signs of any major distress. The one item to note is that the guttering was full of vegetation as noted on photograph No. 50.

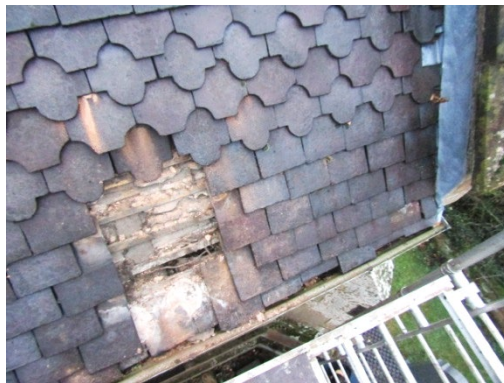
Photograph No. 51

This is the lower area of the southern elevation of the chancel roof, a general view of which is shown on photograph No. 51. This has the detail of the laths and the battens being fixed to the top of the rafters and the fixings of some of the laths is slightly poor at the edges. It is also evident, as noticed on the remainder, that the tiles are bedded, and this can be seen in more detail on photograph No. 52.

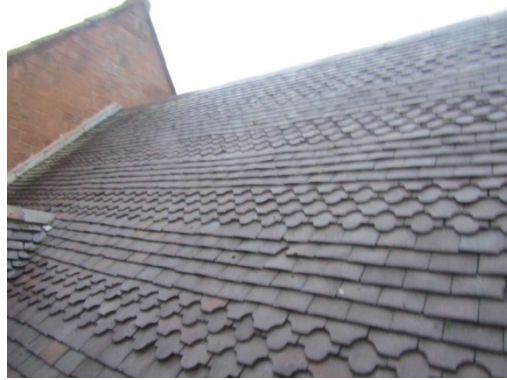
Photograph No. 54

The lower batten at eaves level isn't securely fixed and can be slightly moved and the wall head does need to be cleared out. From the eaves, looking along the roof the line of the tiles was quite reasonable and as previously noted there is an occasional cracked and damaged tile and a general view from this upper section can be seen on photograph No. 54.

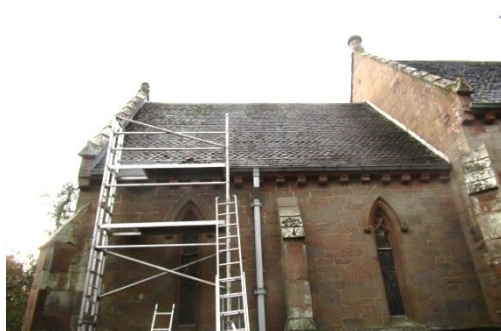
Photograph No. 55

This is to the lower section of the chancel roof on the northern elevation at the eastern end and an area was exposed at the eaves which showed that there was a similar arrangement as per the remainder of the roof. A general view of the area where it was exposed can be seen on photograph No. 55.

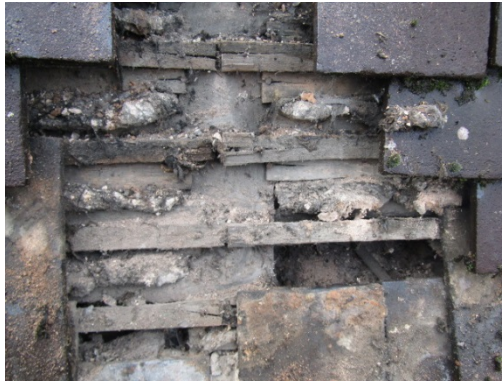
Photograph No. 56

What is evident is that the battens are starting to split at the nail positions and a more detailed view is shown on photograph No. 56 and then splitting of the battens with the nail on photograph No. 57.

When the nails corrode, then there is an expansion which thus splits the relatively thin timber batten or lath. At present, there was no indication of major failure, however looking along the lines of the tiles, that there were small areas where the line was starting to sag slightly which is an indication that the battens have dropped

In terms of timescale for major roofing works, the main issue will be the battens and therefore the recommendation will be that the roof will need re-covering within the next 5 years. In the interim period, carrying out regular maintenance would be recommended, and it has been noted that this is already being carried out noting that flashings have recently been replaced.

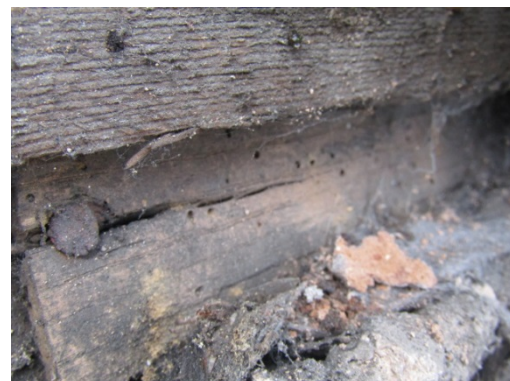
Photograph No. 61

The plaster itself would appear to have a reasonable key, however, on the lath there is a small amount of beetle infestation as shown on photograph No. 60 and again on photograph No. 61 which also shows where it has been split by the corroding nailing fixing.

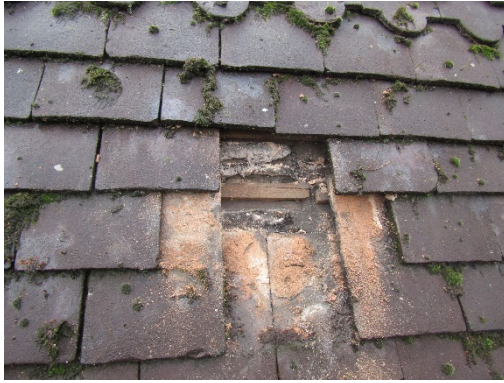
Photograph No. 62

Just above here to the main section, a further area was inspected which did show a reasonable plaster key but a similar situation and again it is clearly evident that the sequence of construction was that the rafters were constructed, then the ceiling laths put in place and then the roofing battens on top. The splitting at the end of the battens and the laths is clearly evident and this is all shown on photograph No. 62, which is a general view, and then in more detail on photograph No. 63.

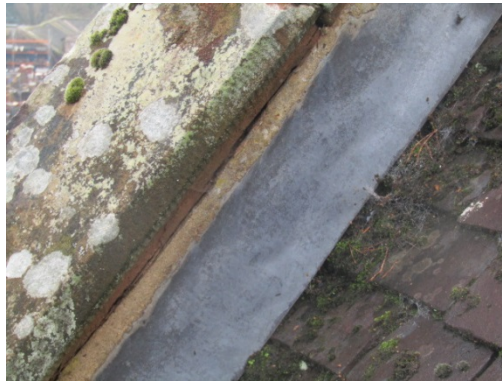
Photograph No. 64

From this position, it is possible to inspect the small flashings to the end parapet wall and it was evident that there is a degree of repointing required as shown on photograph No. 64.

In the first instance, a small contract to ensure that all flashings are well pointed to the stonework and also that where there are small back gutters and valleys, these are completely cleared of vegetation. The vegetation traps moisture which can then ingress through the tiles and as noted with the plaster being directly behind, this can lead to problems and issues of plaster failure.

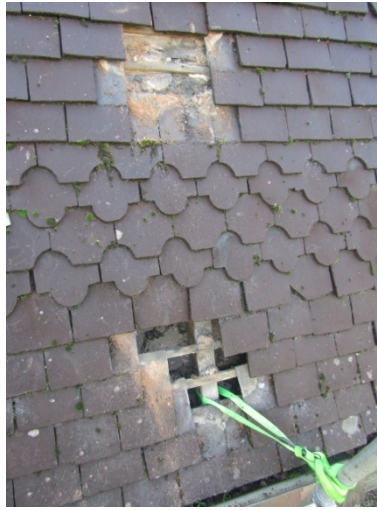
Photograph No. 65

This is the main nave roof on the northern elevation and this area is to the lower part of the eastern side and a general view of the two areas which were exposed can be seen on photograph No. 65.

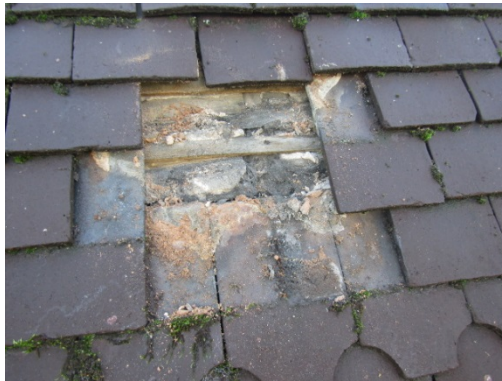
Photograph No. 68

On the upper section, as shown on photograph No. 68, the relationship of the laths for the ceiling and the battens is similar and again there is a reasonable plaster key coming through the laths with just an occasional section having broken off and this can be seen on photograph No. 69.

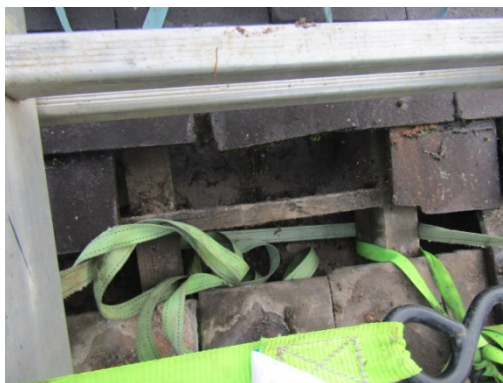
Photograph No. 72

This is taken to the east of the porch on the main nave roof and where the lower eaves was exposed, as shown on photograph No. 72. There is again evidence where the battens are splitting. The remainder is all as previously recorded on the other areas and this section is shown in more detail on photograph No. 73.

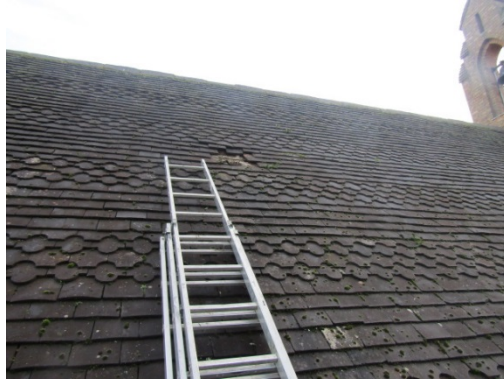
Photograph No. 74

The upper area of roof which was exposed can be seen on photograph No. 74 and it was noticeable that there was moss and a small fern growth on the roof as identified on photograph No. 75.

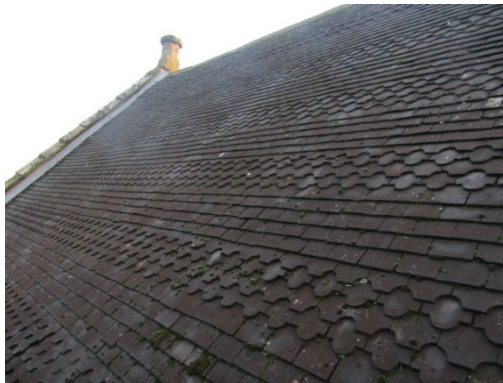
Photograph No. 76

The general condition of the tiles, looking along the roof in both directions, was reasonable, which is recorded on photograph No. 76 looking to the east, and photograph No. 77 looking to the west.

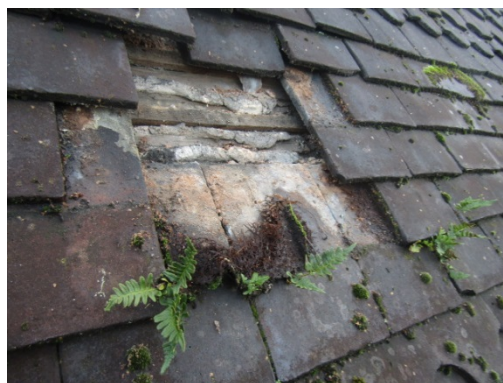
Photograph No. 78

In the area exposed, as shown on photograph No. 78, there is again fern growth beneath the tiles.

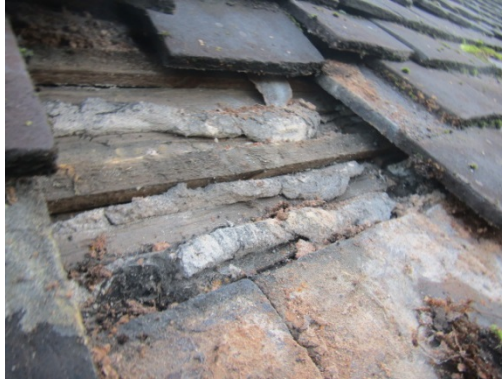
Photograph No. 79

The plaster key is quite reasonable but in this instance there was slight beetle infestation in the batten and the above points are shown on photographs No. 79 and 80.

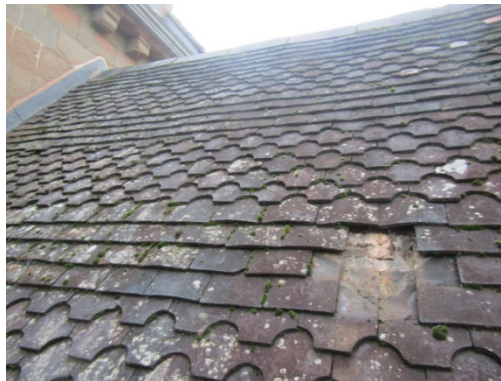
Photograph No. 81

This is on the eastern slope of the porch as shown on photograph No. 81.

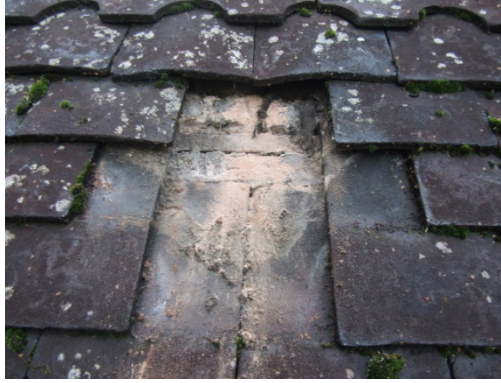
Photograph No. 82

This is of similar construction to the main nave and the plaster key was quite reasonable and there is just very minor evidence of splitting of the battens and a more detailed view can be seen on photograph No. 82.

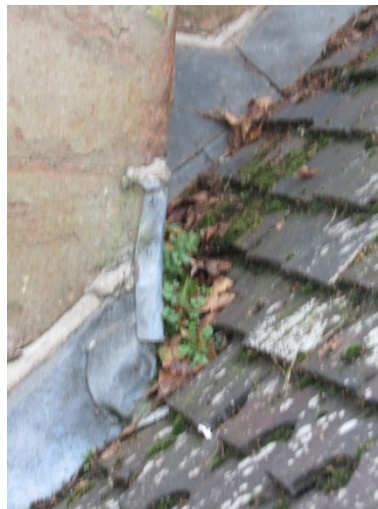
Photograph No. 83

Looking from this position, at the junction with the buttress, there is vegetation in the small back gutter and the main gutter itself is full of vegetative growth, these points being shown on photographs No. 83 and 84.

Overall, the recommendation is that in the short term a small contract is let to clear all the back gutters, main gutters and to check and point the flashings, along with replacing the missing tiles, there being a few noted on the ridge.
